558 LaHave Street

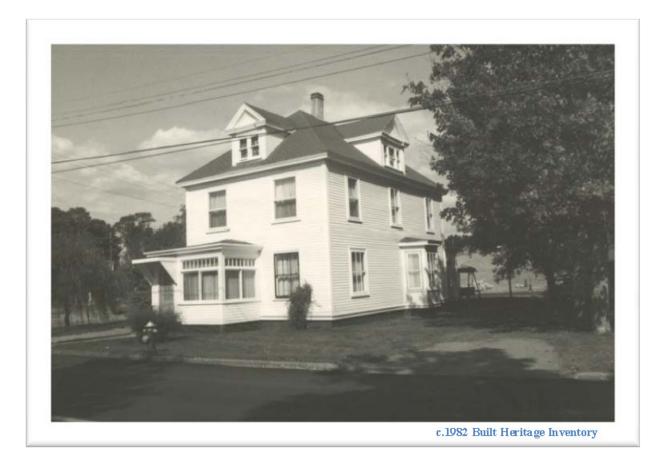
This picturesque home, set in amongst luscious trees (including a weeping willow at left), with an expansive back lawn, was replaced by the Superstore building and its parking lot. Though a Four Square home – an abundant house style in Bridgewater from the early 1900s – its unique features and larger size once surely made it one of the best examples of the first style of mass-produced houses. This was, for up to 58 years, the home of Bridgewater's notable Telfer family. Patriarch Robie F. Telfer was the founder and general manager of Telfer's Woodworking Company Limited, once a prosperous lumber and manufacturing company for many years. The Telfer woodworking factory was once a notable part of Bridgewater's economy. Later, it became Telfer-Crowe Woodworking, and eventually Brady's Building Supplies and Lumber Company. The home itself passed from Robie Telfer to his wife, Deliet A. Telfer, and then to Carol and Joan Tutty, likely her heirs.

Though a stereotypical Four Square style of home, it was not quite square, as its sides once extended an extra *bay* backwards, allowing for three windows on each floor in the side. Conventional houses usually only has two. Included amongst these, at the centre of the first floor, was a large bay window. Additionally, the ground floor windows seem to have been oversized, with a three-over-three arrangement of glass

panes instead of the usual two-over-two. The upstairs front windows also seem to have been quite large. Another lavish addition to the home are the dormers. Instead of hipped dormers, the same style of roof as the house, or less common gable dormers, Telfer installed pedimented dormers. The gable roofs on these have returning eaves that, though slightly recessed in the middle, continue along the top of the window, closing the peak into a pediment. This element, characteristic of the more opulent Queen Anne Revival style that was still common, was added, likely to further the beautification of the house from the layman's home. Though not original, the entryway was also likely changed to its present configuration by Telfer. Four Square homes generally had some variety of porch of veranda for an entrance, whereas the sun porch really only came into style in the 1910s and 1920s. The vestiges of a balustrade or columns supporting the roof are not present, and the large windows are lined up perfectly so that four of the smaller, rectangular panes (characteristic of the Arts and Crafts movement) are above each. This suggests that the original veranda or porch was removed and this one was added on to (partially) replace it.
